# Middle Rio Grande Conservation Action Plan

## *Framework and Status Assessment*

## Final Report

April 2015

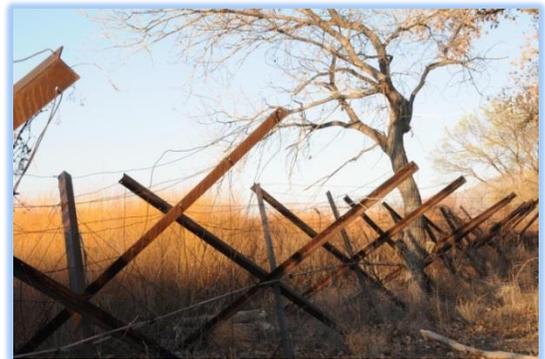
**Kellner jetty jacks were installed along the banks and through the floodplain to stabilize and prevent lateral movement of the river channel.**

Over the course of the last 90 years, a variety of methods have been used to channelize the river including levees, groins, Kellner jetty jacks, and dredging. The end result has been a significantly narrower and deeper active channel that flows between raised terraces of deposited sediment within the levee system. This is effective for water delivery and flood control, but is detrimental to the wetland and riparian flora and the native aquatic fauna. As the active channel has become progressively more isolated from the adjacent terraces there has been a decrease in the extent and frequency of overbank flooding onto the terraces, coupled with a retreating groundwater table in the terraces. The lack of overbank flooding means that many of the native riparian woody species can no longer reproduce outside of the active channel. The lack of geomorphological diversity in the active channel and overbank flooding outside the channel also impacts the reproductive success of endangered native fish species. The retreating groundwater has

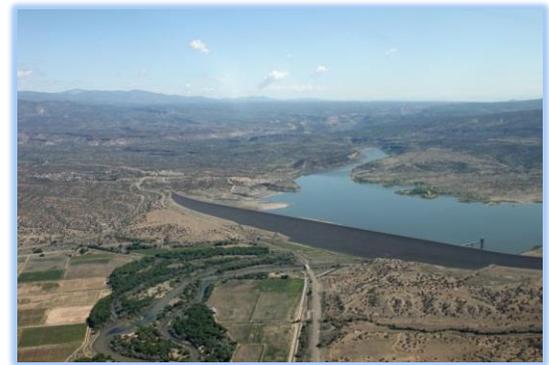
**Cochiti Dam lies at the northern boundary of the MRG reach and is the primary means of water regulation.**

The dams create two key stressors on viability for the Middle Rio Grande ecosystem; one is alteration of the timing, volume, and duration of the downstream water flow, and the other is removal of sediment from the flow. Flow regulation by the dams has created a separation of the river from its historical hydrograph such that the amount of water now flowing through the river can be largely unrelated to natural seasonal water availability. Prior to dam construction, the river typically had late spring/early summer peak flows driven by snow melt in its Southern Rocky Mountain headwaters. This peak flow often resulted in floods that spread sediment and water across the floodplain, and provided many opportunities through channel evulsion and floodplain reworking for the formation of new wetlands, the establishment of young stands of native woody species, and the revitalization of others—creating new habitats for numerous native plants and animals. The creation of these new habitats often came at the destruction of existing patches of woodlands, shrubs, or wetlands, keeping the ecosystem in a dynamic state of flux. The spring flood pulse was the driver of the dynamic patch mosaic that was the key to the vitality and diversity of the bosque ecosystem. This spring flood pulse was also a

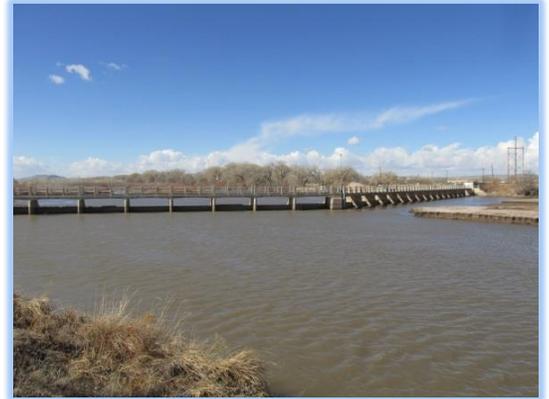
The Isleta diversion dam provides irrigation water for the MRGCD Belen Division.

The dams and other diversion infrastructure can be a direct threat to fish by impeding movement up or down channel, especially if fish become trapped in areas that may dry completely and create population sinks. Impediment of up- and down-channel movement can also create genetic isolation between fish populations.

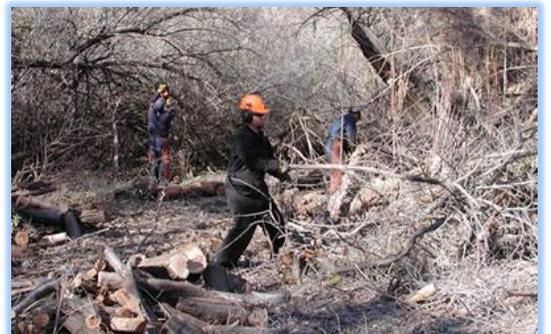
Understory treatments to reduce fire hazards can impact wildlife habitat and vegetation diversity depending on how they are done.
