**RECOMMENDED BEST  
MANAGEMENT  
PRACTICES  
for Pagosa Bladderpod  
(*Physaria pruinosa*)**

**Practices Developed to  
Reduce the Impact of  
Road Maintenance Activities  
to Plants of Concern**

**Colorado Natural Heritage Program**

June 2017

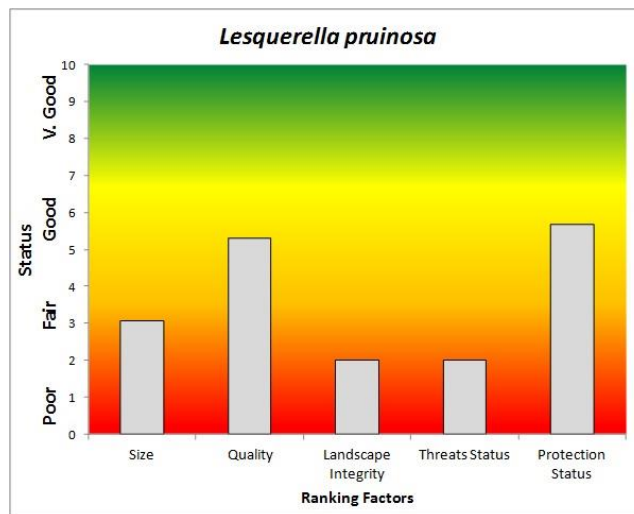
Summary results of an analysis of the status of Pagosa bladderpod (*Physaria pruinosa*=*Lesquerella pruinosa*) based on several ranking factors. This species was concluded to be "moderately conserved".  
 From Rondeau et al. 2011.

Residential and commercial developments are considered to be the primary threats to the species at this time (Rondeau et al. 2011). The city of Pagosa Springs lies within the plant's range. Residential growth, development of resort homes, and increased tourism due to the development of a proposed ski resort 20 miles east of Pagosa Springs threaten occurrences. Archuleta County is growing rapidly, and future land use plans that have been drafted by Archuleta County do not include adequate provisions for the protection of Pagosa bladderpod (Anderson 2006).

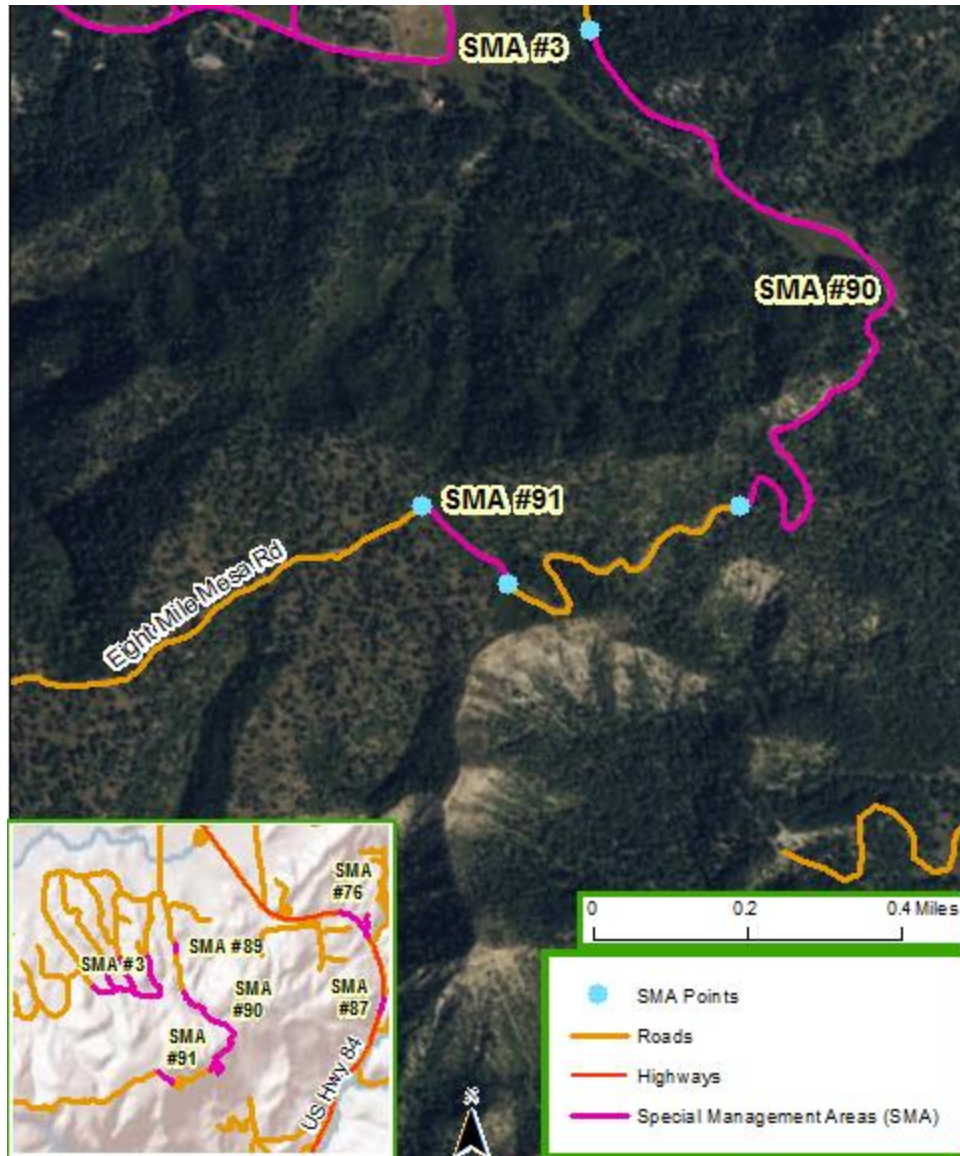
| Special Management Area (SMA) Number | SMA #91 |

| Road Name | Eight Mile Mesa Rd |
| % of rare plant occurrence in SMA | 0.64% |

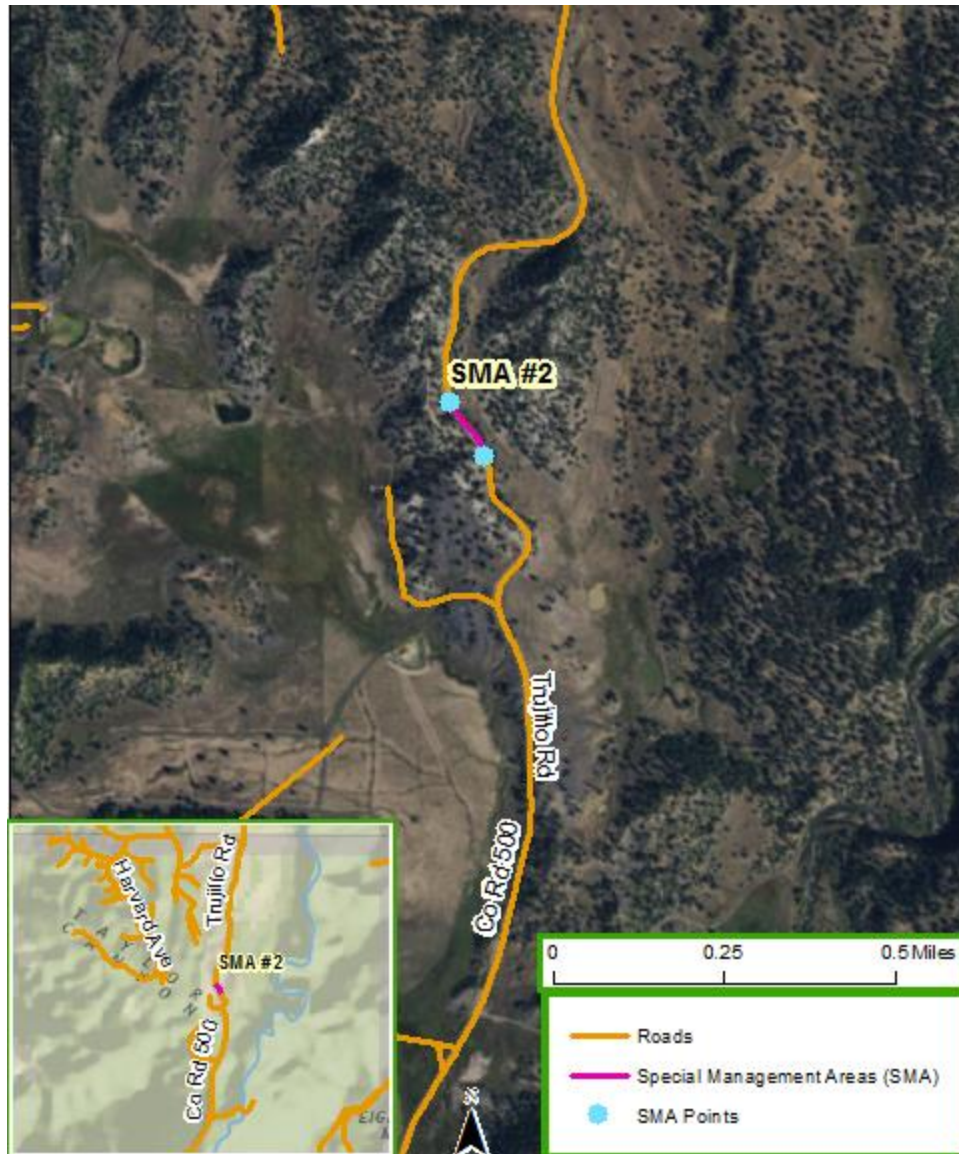
| Special Management Area (SMA) Number | SMA #2 |

| Road Name | No Data |
| % of rare plant occurrence in SMA | 0.07% |

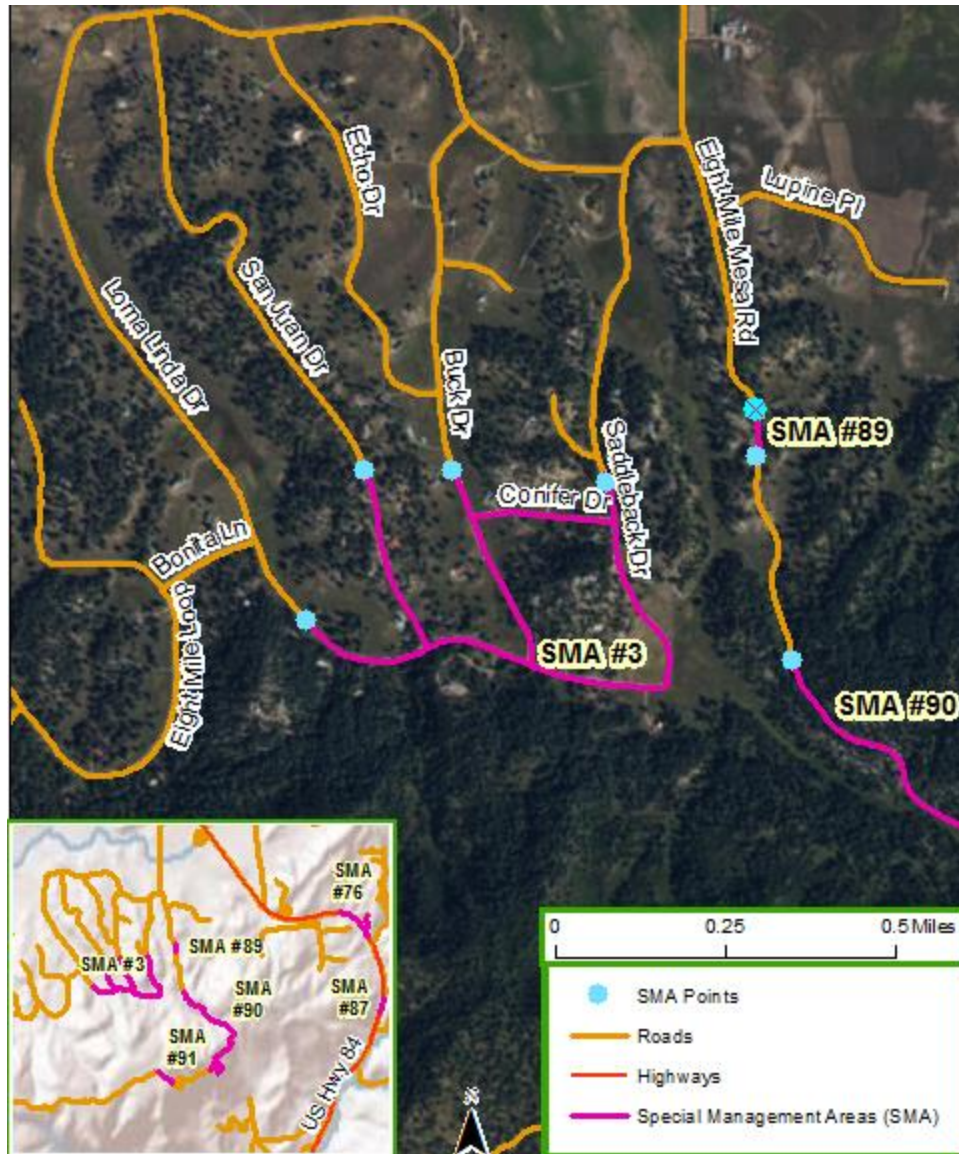
| Special Management Area (SMA) Number | SMA #3 |

| Road Name | Saddleback Dr, Loma Linda Dr, Conifer Dr, Buck Dr, San Juan Dr |
| % of rare plant occurrence in SMA | 5.03% |
